| REPORT DOCUMENTATION PAGE | | READ INSTRUCTIONS BEFORE COMPLETING FORM |
|--|---|--|
| 4. TITLE (and Subtitle) Phase I Dam Inspection Report National Dam Safety Program Loss Lake Dam (MO 30262) Dent County, Missouri | | 5. TYPE OF REPORT & PERIOD COVERED Final Report |

LOSS LAKE DAM
(Formerly No Name 112)

PHASE I INSPECTION REPORT
NATIONAL DAM SAFETY PROGRAM

NOVEMBER, 1978

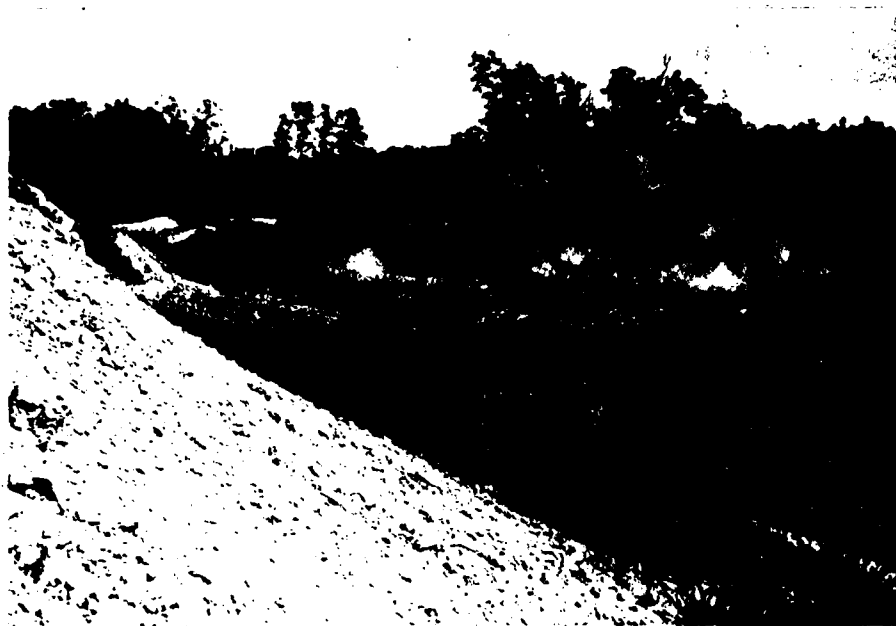
PHOTO 3 View of Spillway Looking Downstream

C. Appurtenant Structures. A spillway is located on the left abutment, cut into residual soil without any erosion protection. A small earth dike was located at the upstream end of the spillway and in line with the crest of the dam. A wire mesh screen is set up in the spillway outlet channel which has created a pool of muddy water with the small earth dike. Spillway discharges may endanger the integrity of the dam.

(4) The spillway and outlet channel should be protected from erosion.
